UNITED STATES AIR FORCE RESEARCH LABORATORY

Prevention Effectiveness Foreign Object Debris Study (PrE-FOD)

February 1998
Interim Report for the Period August 1997 to February 1998

AFRL-HE-WP-TR-1998-0119

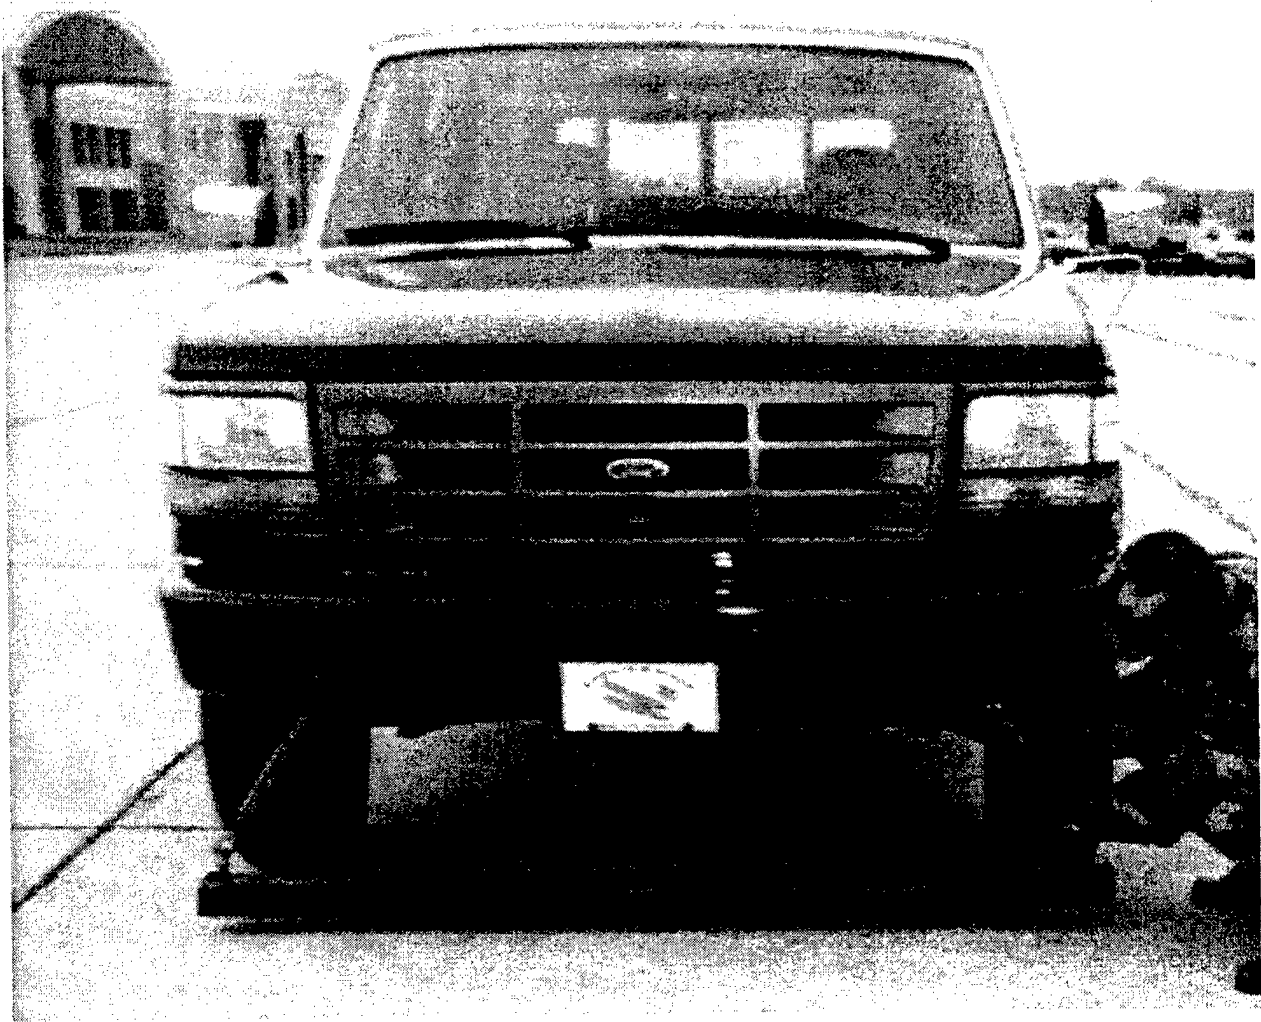
Figure 4. Magnetic Bar

Figure 4 shows a magnetic bar attached to the front bumper of a flightline vehicle. The magnetic Bar is a large, pre-magnetized piece of steel, hung from flight line vehicles to pick up metallic FOD. This steel bar is normally covered with approximately 1/4 inch of rubber to make removal of metal objects easier.

Accuracy and angle of magnetic bar distance above the ramp surface. The connection of the magnetic bar to the expediter truck was accomplished using a cargo tie down strap. This strap allowed the bar to slide from side to side. At times the bar had to be readjusted because one end would become lower. It was also noted that many times the front of the bar would be lower than the back of the bar making the bar surface unparallel to the ramp surface. No evaluations were made of the effect of either of these occurrences on the efficiency of the pick up.
